# Inner Basin Pipeline & Waterline Road **Reconstruction & Relocation Project**

October 25, 2012

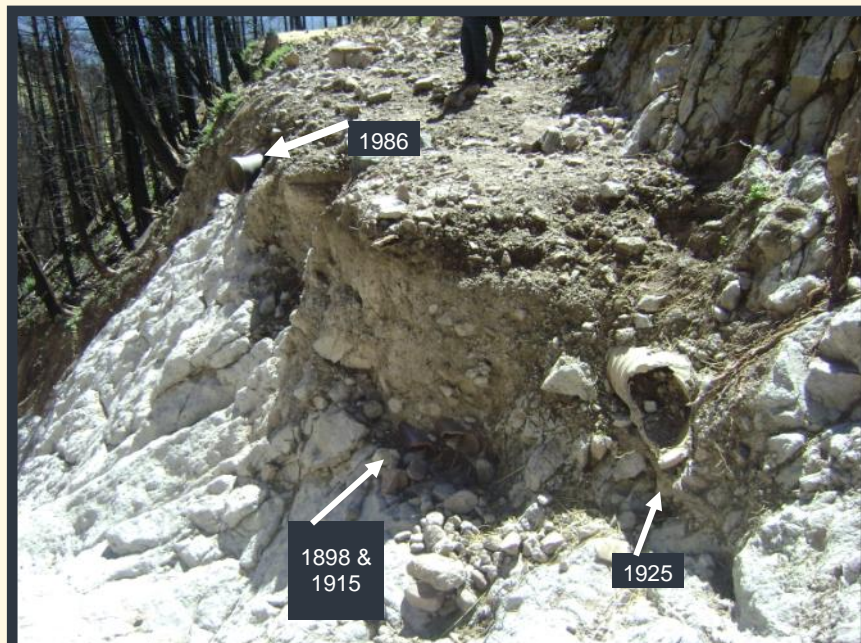
**PIPELINE HISTORY EXPOSED IN DRAINAGE—Sept. 9, 2010**  
All pipelines were severed at this location (Site 2) along Waterline Road following storms of the 2010 monsoon season. Photo: Mark Shiery, USDA Forest Service, Rocky Mountain Research Station

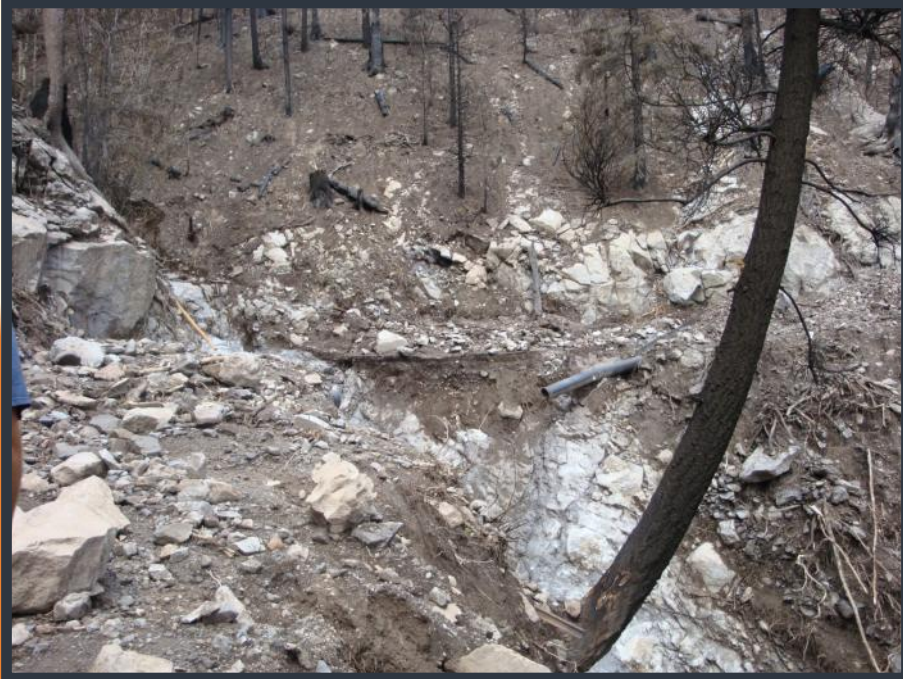
### SITE 2 DAMAGE ASSESSMENT

**Damage Assessment:** Very Severe  
**Nature of Damage:** Erosion at a natural inside drainage at a major valley or ravine  
**Pipe Condition:** 40 feet of 16-inch DIP lost and missing, another 19 feet exposed  
**Lost Material:** About 1,850 cu yds  
**Mass Wasting Character:** Flowing rock and larger trees and vegetation  
**Hunter/Jacobs Mitigation Design:** Upstream/Downstream Crossing Repair

Heavy erosion at drainage crossing including severed 16-inch DIP (left), and erosion to bedrock up-gradient (below), August 4, 2010. Photo: City of Flagstaff, Utilities Division

Site 2 is located in the bend of the road at a major valley or ravine location. Stormwater runoff has traditionally passed over the access road and continued downstream in the ravine. With the event of the Schultz Fire, runoff rates have nearly doubled and upstream debris both in the form of flowing rock as well as large trees and uprooted vegetation are flowing down the valley. The flowline has reached equilibrium grade as much of the ravine has been lowered to the bedrock elevation, nearly 25 feet lower than the pre-fire drainageway profile. Loss of cover material up slope and down slope resulted in the exposure of bedrock.

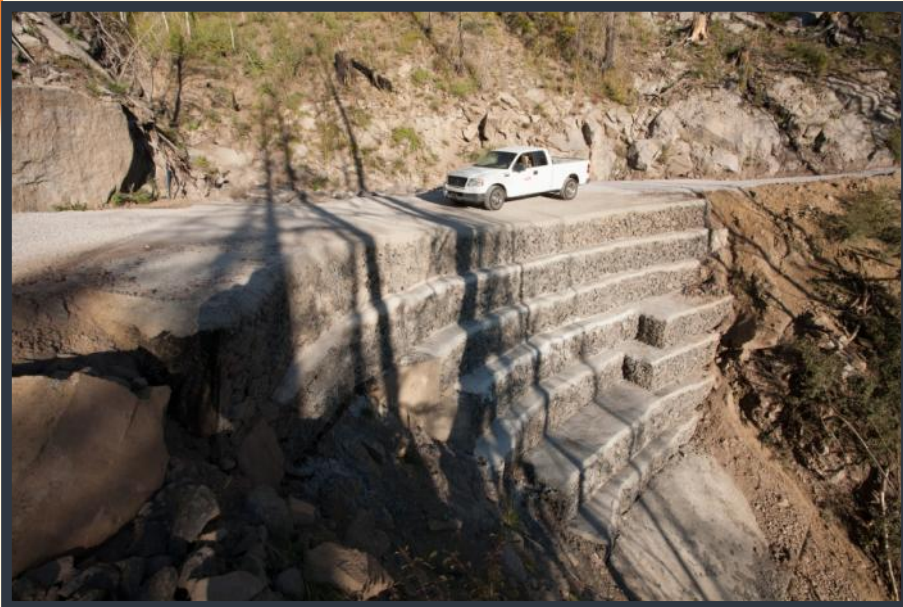
### SITE 2 FINAL CONSTRUCTION

(Above) Gabion structure, September 27, 2012.  
 (Right) Completed road crossing, September 27, 2012.  
 Photos: Tom Alexander Photography

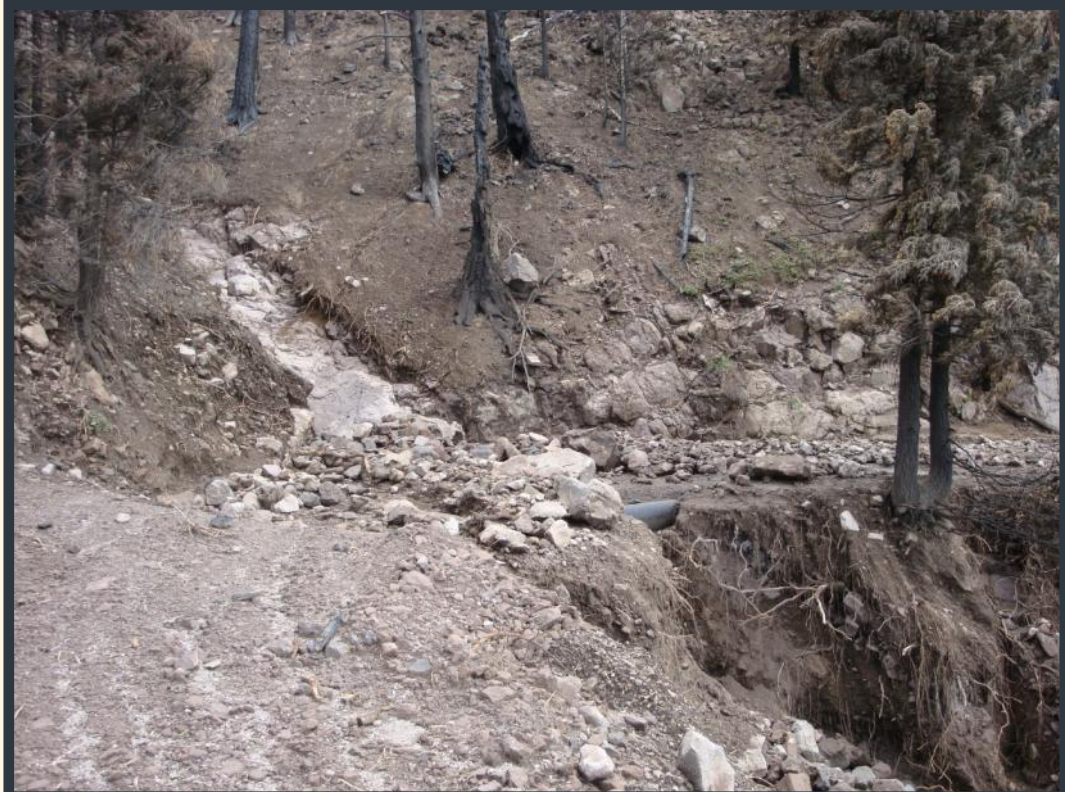
### SITE 4 AFTER FIRST MAJOR MONSOON EVENT

View looking at drainage crossing and exposed 16-inch DIP on August 4, 2010. City of Flagstaff, Utilities Division

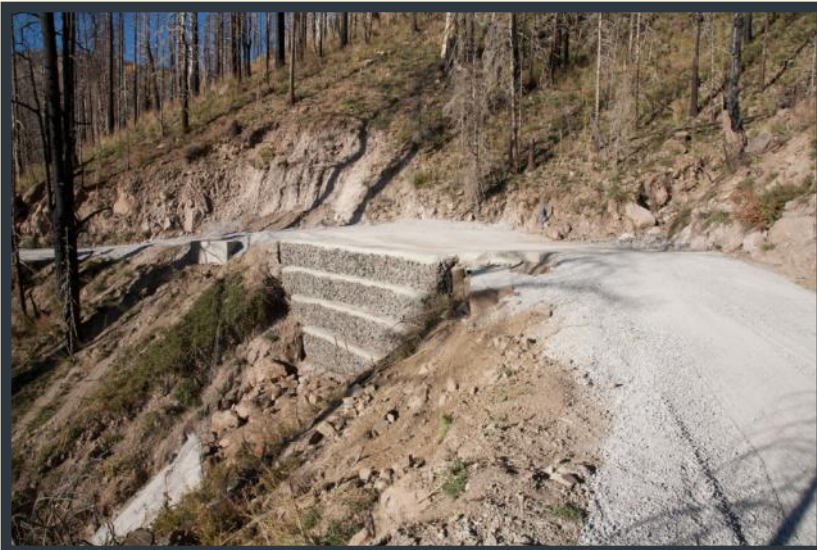
### SITE 4 FINAL CONSTRUCTION

Completed road crossing (above), and view looking up-gradient (right), September 27, 2012. Photo: Tom Alexander Photography

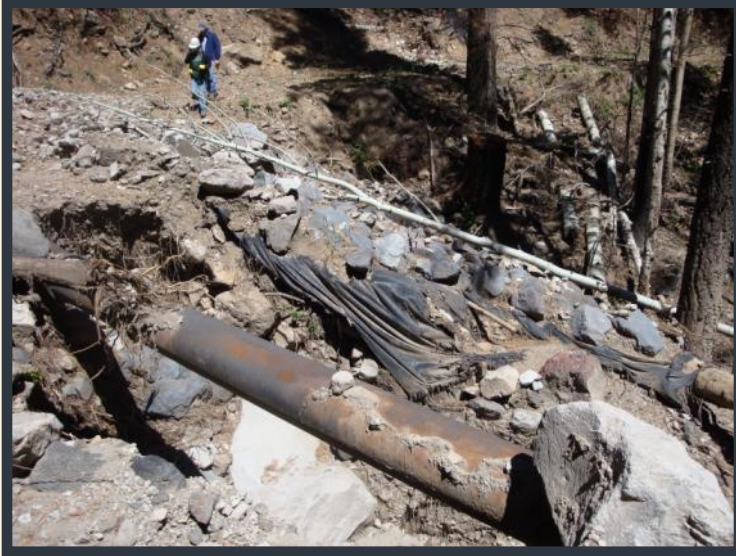
### SITE 5 POST-MONSOON

View looking at drainage crossing and exposed and suspended 16-inch DIP, September 9, 2010. Note the damaged geotextile fabric installed by the BAER team. Photo: FEMA

**Damage Assessment:** Severe

**Nature of Damage:** Erosion of a natural inside drainage area at a major valley location

**Pipe Condition:** 70 feet of 16-inch DIP exposed and still in place

**Hunter/Jacobs Mitigation Design:** Minor Drainage Crossing Repair

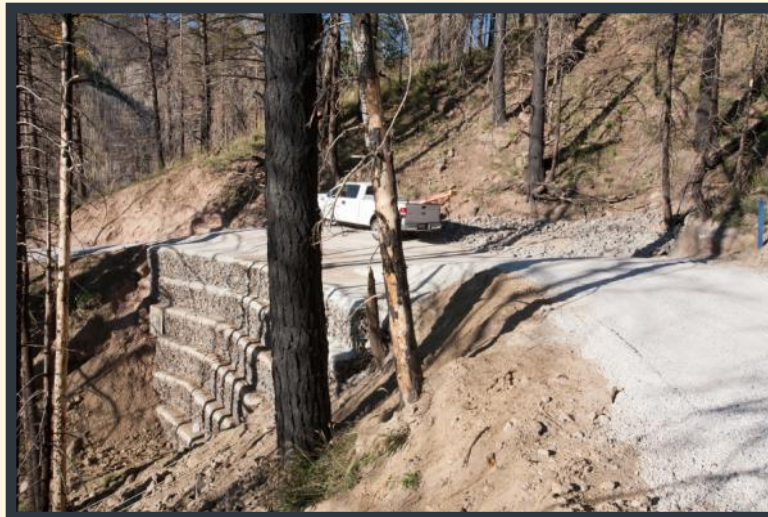
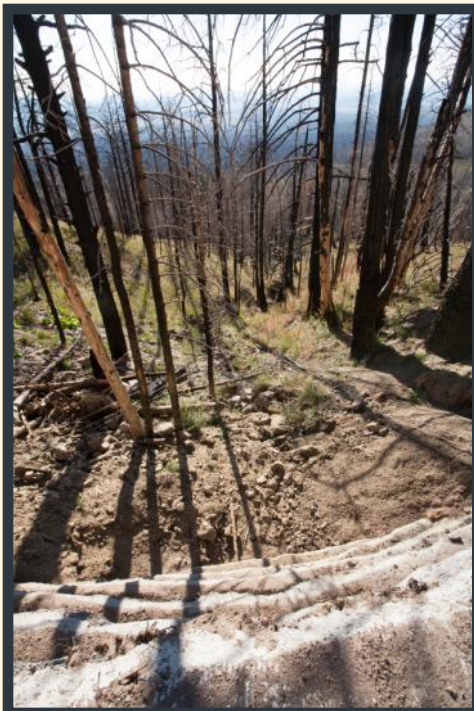
### SITE 5 FINAL CONSTRUCTION

Completed road crossing (above), view looking down-gradient (left) and up-gradient (right), September 27, 2012. Photo: Tom Alexander Photography

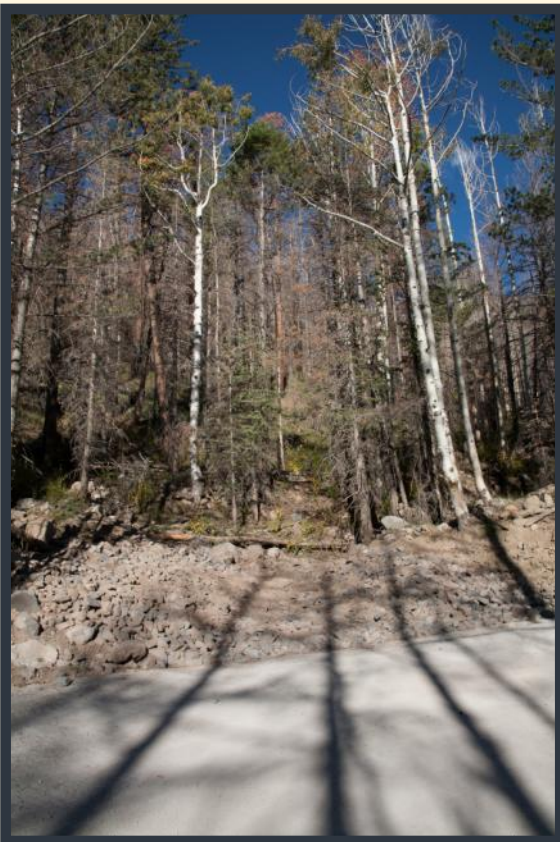
## SITE 7 FINAL CONSTRUCTION

View looking up-drainage from completed road crossing (above), and view looking at road crossing and gabion structure (right), September 27, 2012. Photos: Tom Alexander Photography

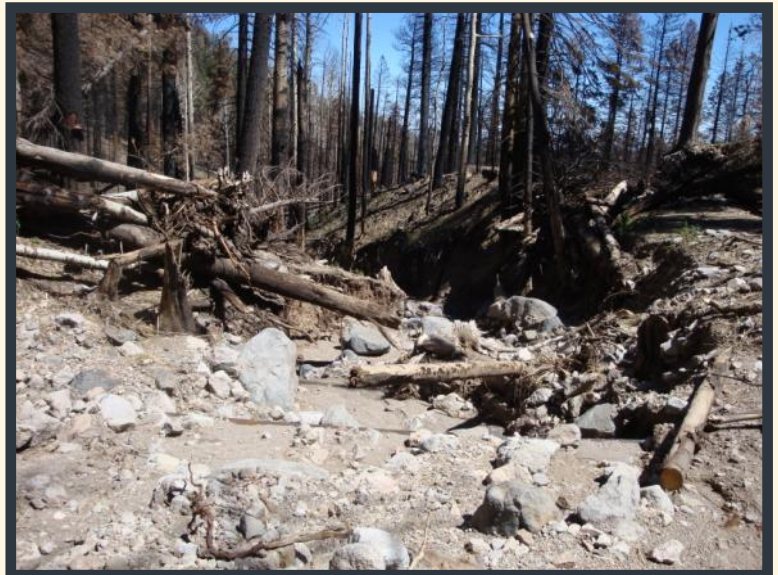
## SITE 7 POST-MONSOON

View looking down-gradient from road crossing, September 9, 2010. Photo: FEMA

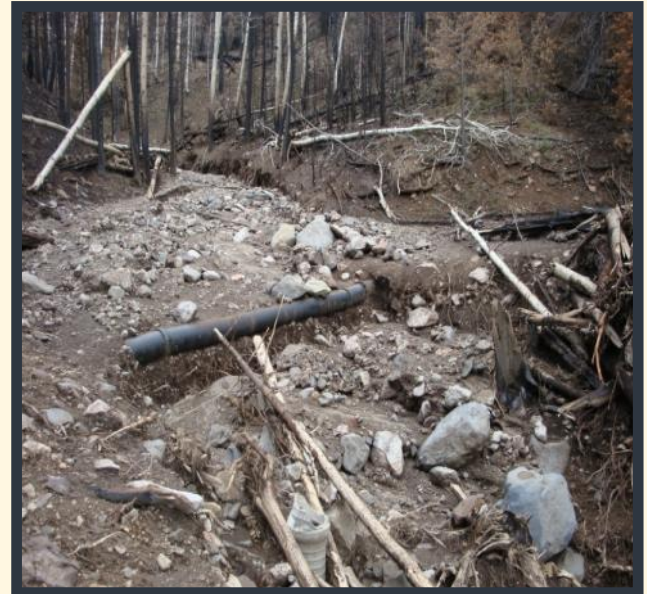
## SITE 9 AFTER FIRST MONSOON EVENT

**Damage Assessment:** Severe

**Nature of Damage:** Upslope debris flow at major valley location

**Pipe Condition:** 16-inch DIP exposed but partially embedded for about 30 feet

Drainage crossing and exposed 16-inch DIP, August 4, 2010. Photo: City of Flagstaff, Utilities Division

**Hunter/Jacobs Mitigation Design:** Minor Drainage Crossing Repair

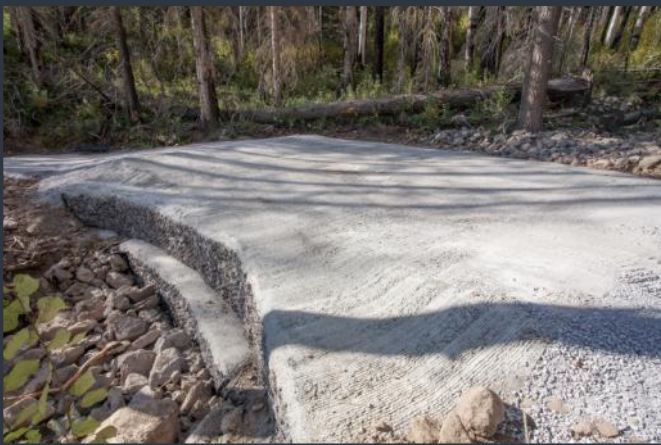
## SITE 11 FINAL CONSTRUCTION

Completed road crossing, September 27, 2012. Photo: Tom Alexander Photography

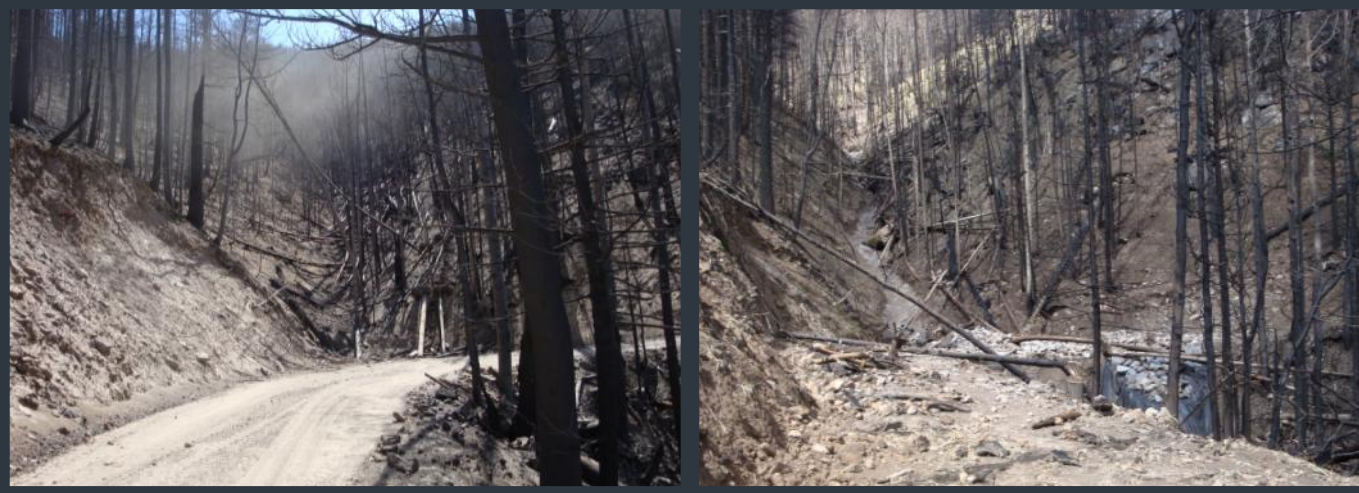
## SITE 14 POST-FIRE & PRE-MONSOON (LEFT) & AFTER FIRST MAJOR MONSOON EVENT (RIGHT)

**Damage Assessment:** Severe  
**Nature of Damage:** Erosion and loss of cover material at a natural inside drainage area at a major valley location

**Pipe Condition:** 40 feet of 16-inch DIP exposed and still in place

Similar in geometry with slightly more severe erosion conditions than Site 7, Site 14 is located in the bend of the road at a major valley location. The access road embankment has eroded away down to near bedrock, the embankment and sideslopes have experienced significant erosion and rutting. This site has minimal loss of cover upslope and more severe erosion to bedrock downslope. Upstream debris in the form of displaced soil and flowing rock are depositing at the upstream segment of this crossing. The pipeline itself for a period of time was acting as a grade control structure that was preventing further upstream erosion. The headcutting undermined the materials around the pipe and continued to erode upstream of the pipe itself, leaving the pipe exposed above existing ground.

View looking at drainage crossing on July 7, 2010 prior to the onset of the monsoon season (left), and on August 4, 2010 after the first major monsoon event that occurred on July 20, 2010 (right). Notice the slight depression in the drainage (swale) with no defined channel bottom in the photo on the left and the debris and scour to bedrock in subsequent photos. Photos: Utilities Division, City of Flagstaff

**Hunter/Jacobs Mitigation Design:** Upstream/Downstream Crossing Repair

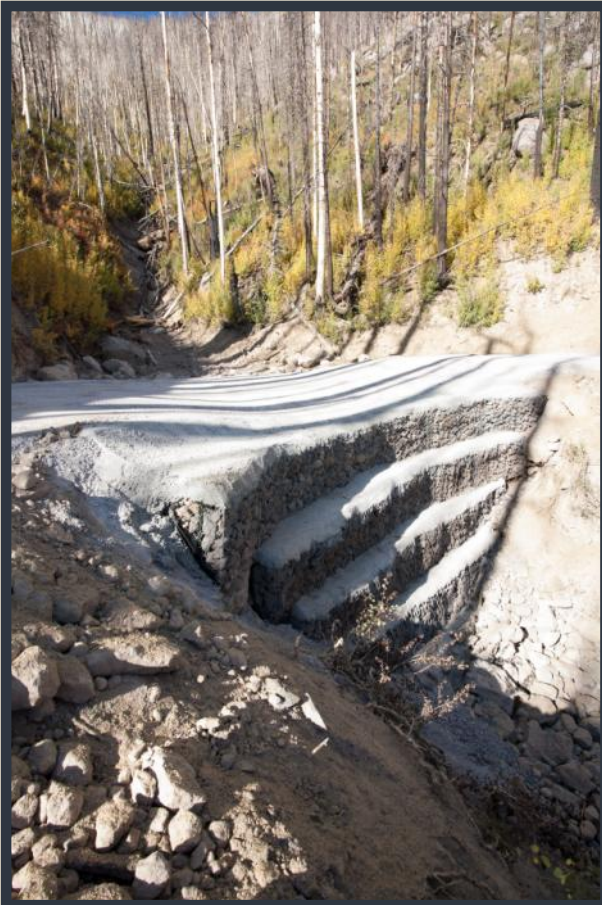
## SITE 14 FINAL CONSTRUCTION

Completed road crossing and gabion structure, September 27, 2012. Photo: Tom Alexander Photography

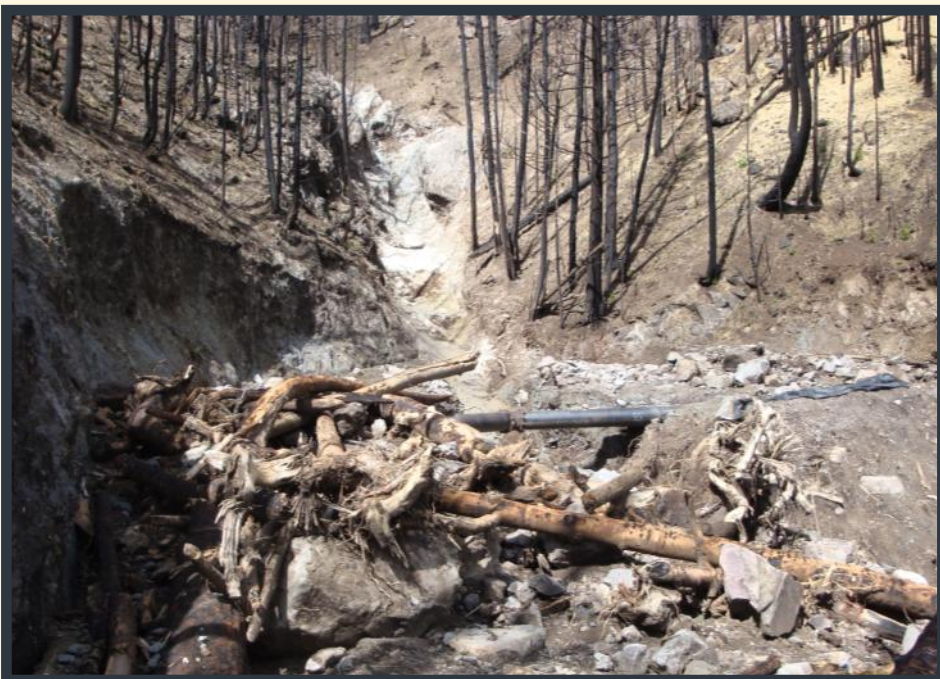
## SITE 15 AFTER FIRST MAJOR MONSOON EVENT

Similar in geometry with and erosion to the conditions of the previous Site 14, Site 15 is located in the bend of the road at a major valley location. The pipeline itself for a period of time was apparently acting as a grade control structure that was preventing further upstream erosion. Ultimately, the headcutting undermined the materials around the pipe and continued to erode upstream of the pipe crossing itself, leaving the pipe exposed above the existing ground. The access road embankment has eroded away down to near bedrock and the embankment and sideslopes have experienced significant erosion and rutting. Runoff continues to erode downstream soils to find a point of equilibrium that has yet to be achieved, but is still very rocky in nature.

View looking at drainage crossing, exposed 16-inch DIP, and erosion to bedrock above, August 4, 2010. Photo: Utilities Division, City of Flagstaff

**Damage Assessment:** Severe

**Nature of Damage:** Erosion of a natural inside drainage area at major valley location

**Pipe Condition:** 40 feet of 16-inch DIP exposed and suspended but still in place

**Hunter/Jacobs Mitigation Design:** Upstream/Downstream Crossing Repair

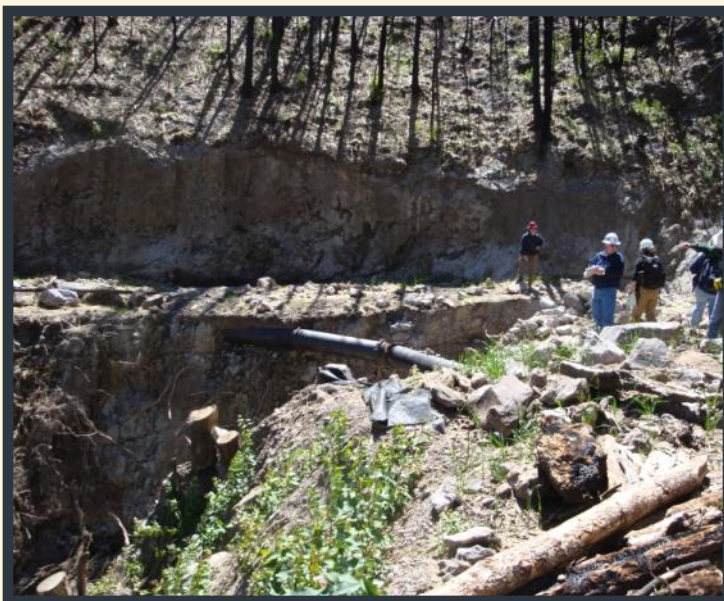
## SITE 15 POST-MONSOON

View looking at drainage crossing and suspended 16-inch DIP, September 9, 2010. Photo: FEMA

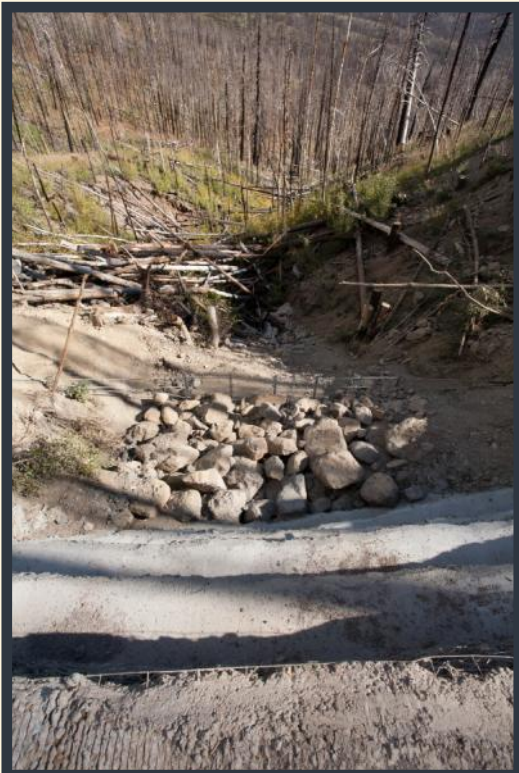
## SITE 16 FINAL CONSTRUCTION

Completed road crossing (above), and view looking down-gradient (left), September 27, 2012. Photos: Tom Alexander Photography

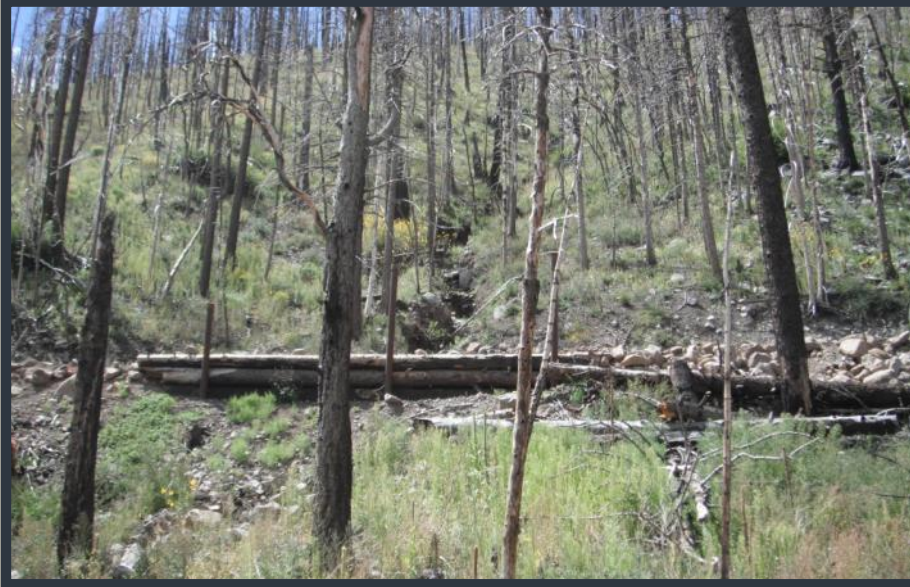
## TIMBER WALL CONSTRUCTION

Timber construction as retaining structures, September 6, 2012. Photo: Erin Young, Fluid Solutions

There are 23 locations where timber retaining walls were built along Waterline Road. These locations were experiencing damage from flows that were eroding the edges of the roadway. Runoff was concentrating to a single discharge point and head-cutting through the roadway surface. At these locations a timber retaining structure was constructed such that the runoff will continue to use the same path through the site but the roadway will be protected from further erosion.

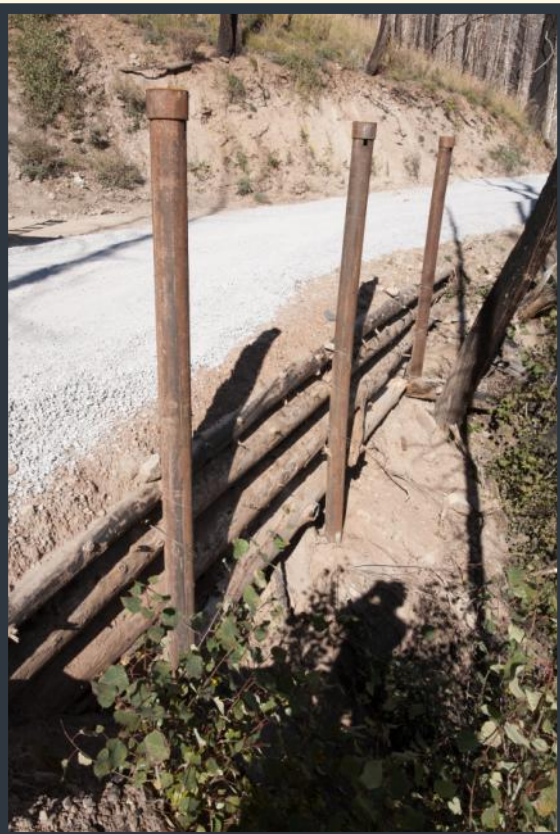
## TIMBER WALL CONSTRUCTION

Timber retaining wall construction showing vertical steel pipe supports, September 27, 2012. Photo: Tom Alexander Photography

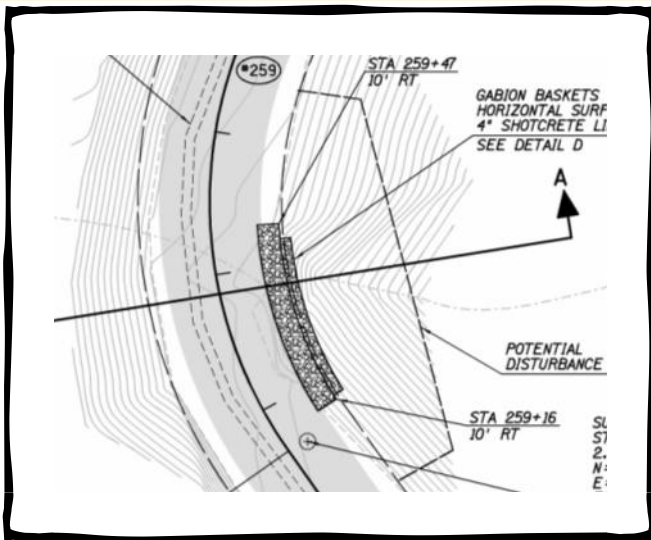
## SITE 18 POST-MONSOON & FINAL CONSTRUCTION

**Damage Assessment:** Moderate

**Nature of Damage:** Sheetflow at moderate bend in road where minor depression upstream concentrates flows

Site 18 is located at a moderate bend in the access road where there is a minor depression in the upstream topography to concentrate the upstream flows to this location. The embankment and sideslopes are experiencing significant erosion resulting in the reduction of the access road and supporting embankment. The runoff continues to erode the downstream soils to find a point of equilibrium that has yet to be achieved, but left alone, will headcut through the access road and expose the pipeline.

(Above) Damage to road and to outside edge of road, September 9, 2010. Photo: FEMA

**Hunter/Jacobs Mitigation Design:** Minor Drainage Crossing Repair

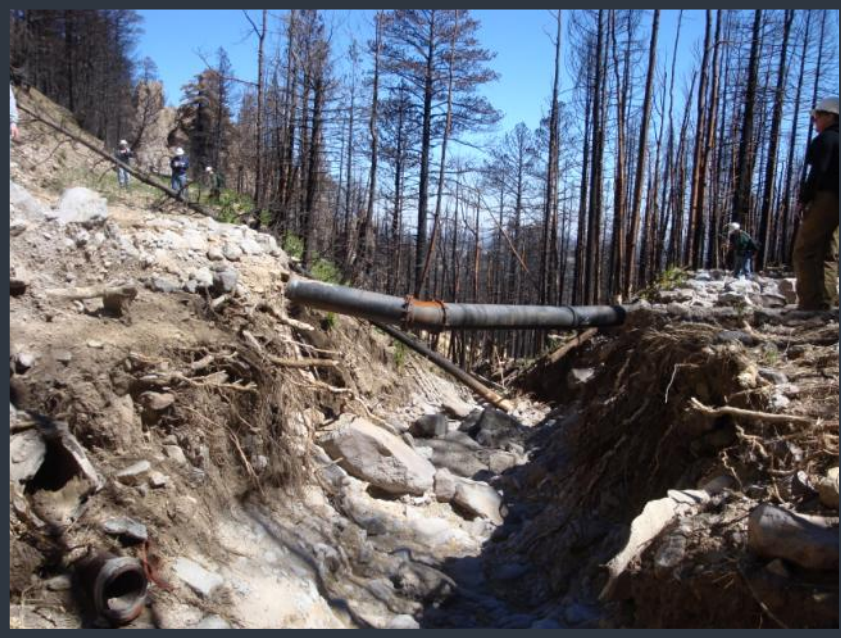
### SITE 20 POST-MONSOON

At this location, 16-inch pipe was removed to rebuild the slope and regain the 24-inch minimum cover over the DIP. The flowline had reached an equilibrium grade as much of the ravine has been lowered to be either at or near the bedrock elevation, nearly 25 feet lower than the pre-fire drainageway profile.

**Damage Assessment:** Very severe

**Nature of Damage:** Erosion at a major valley or ravine at a natural inside drainage

**Pipe Condition:** 16-inch DIP was suspended in place

Exposed 16-inch DIP at drainage crossing, September 9, 2010. Photo: FEMA

**Hunter/Jacobs Mitigation Design:** Upstream/Downstream Crossing Repair

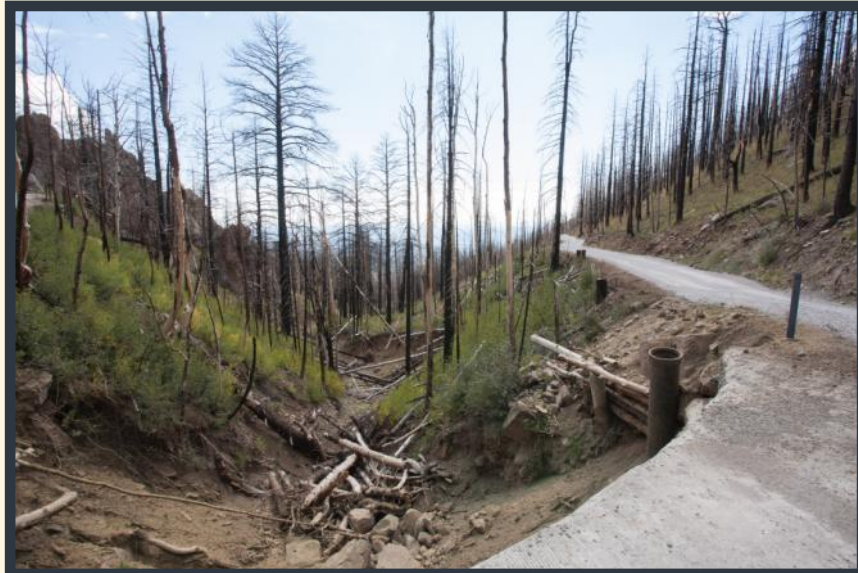
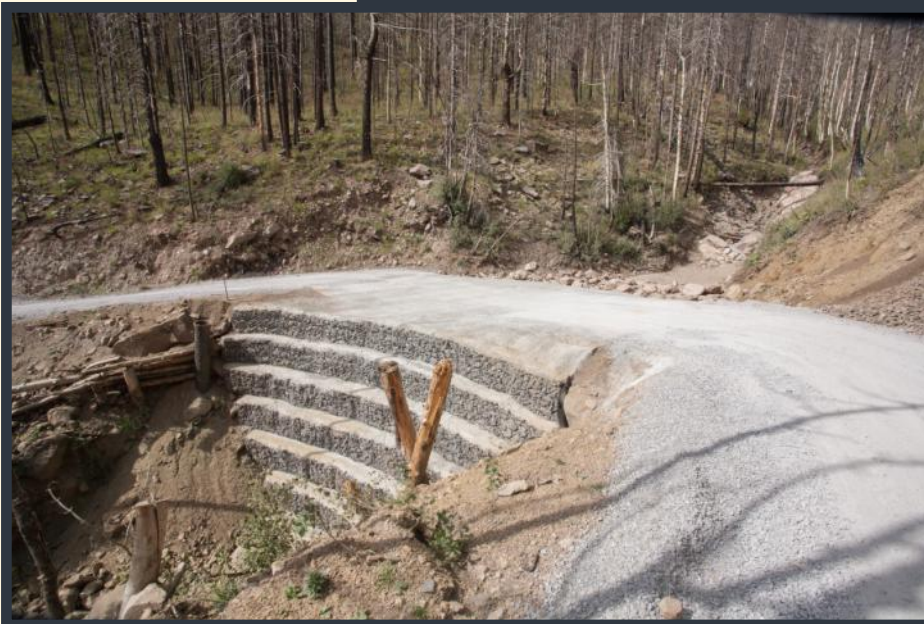
### SITE 20 FINAL CONSTRUCTION

(Above) View looking down gradient, September 27, 2012.

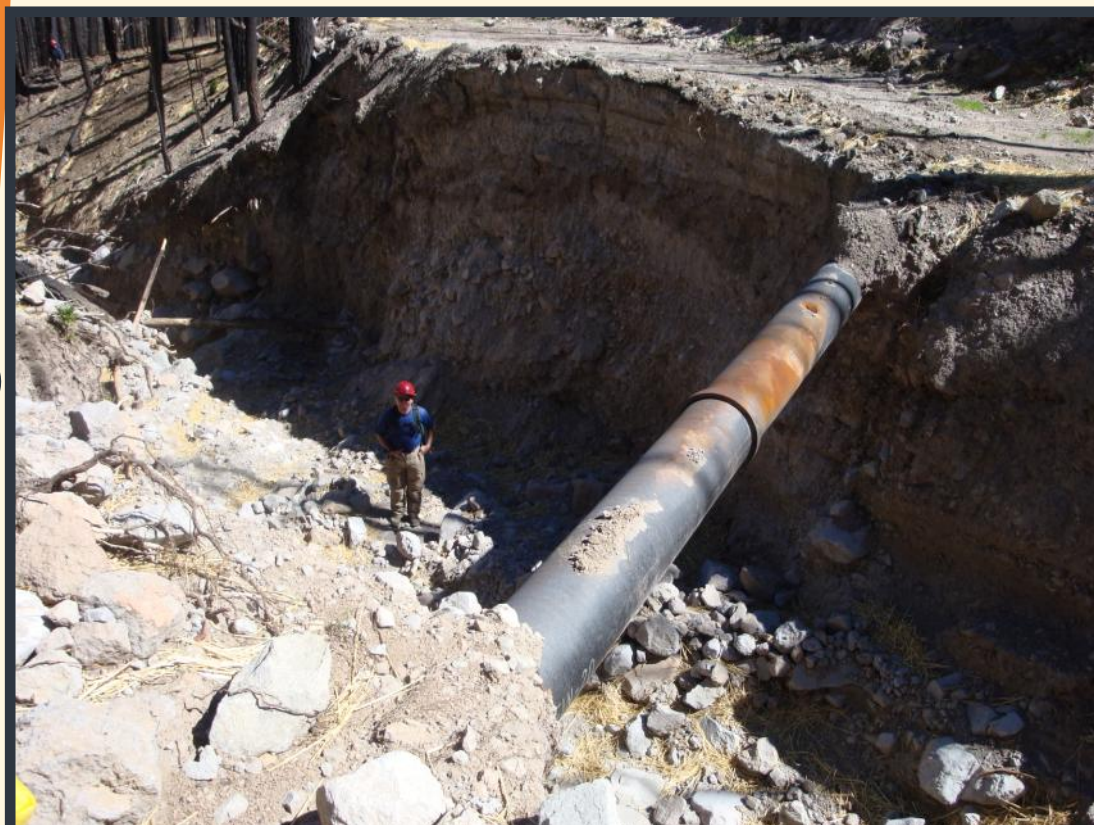
## SITE 22 POST-MONSOON

Exposed 16-inch DIP at drainage crossing, September 9, 2010. Photo: FEMA

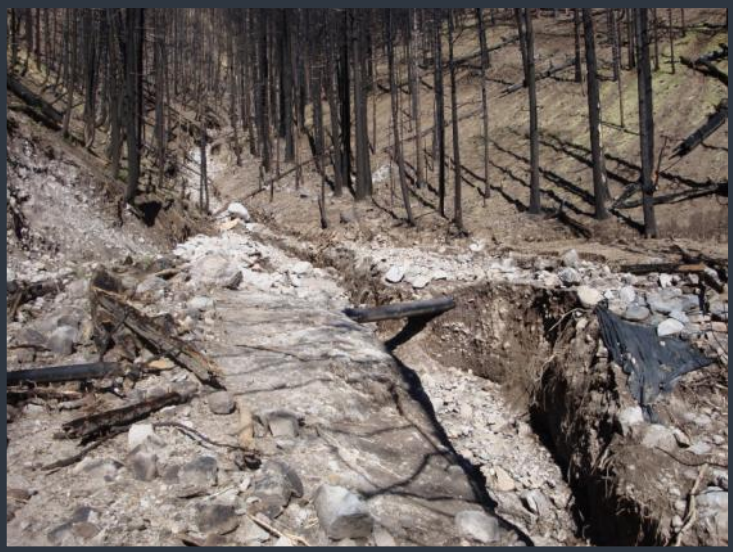
## SITE 22 AFTER FIRST MAJOR MONSOON EVENT

View looking at drainage crossing and suspended DIP on August 4, 2010. Photo: City of Flagstaff, Utilities Division

**Damage Assessment:** Very Severe

**Nature of Damage:** Erosion at a natural inside drainage at a major valley or ravine location

**Pipe Condition:** 50 feet of DIP exposed and suspended; one joint of DIP had a 3-inch hole in the top of the barrel

**Hunter/Jacobs Mitigation Design:** Upstream/Downstream Crossing Repair

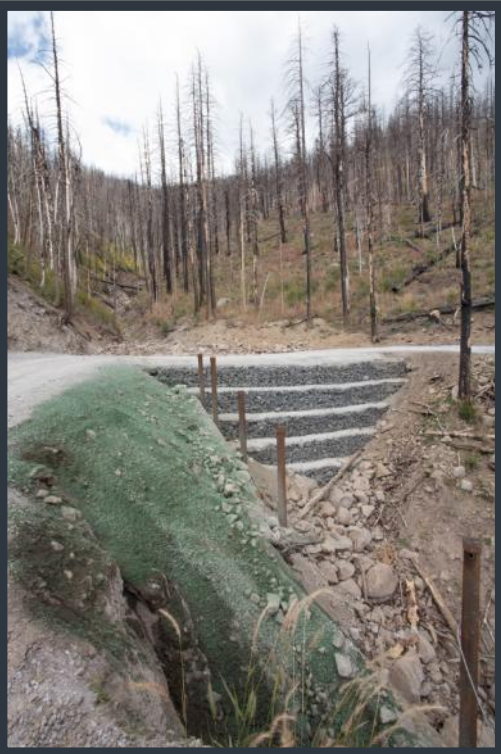
## SITE 22 FINAL CONSTRUCTION (LEFT & BELOW)

Completed road crossing gabion structure and timber retaining wall, September 27, 2012. Photo: Tom Alexander Photography

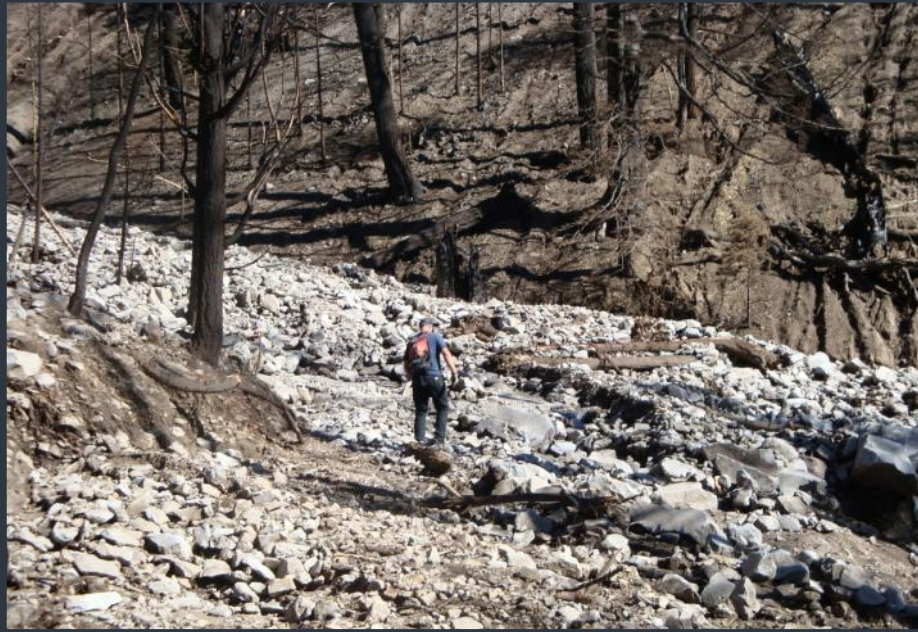
## SITE 24 AFTER FIRST MAJOR MONSOON EVENT

## SITE 24 DAMAGE ASSESSMENT

**Damage Assessment:** Severe  
**Nature of Damage:** Loss of cover material where bend occurs in road at major valley location  
**Pipe Condition:** 30-feet of 16-inch DIP exposed  
**Lost Material:** About 1,850 cu yds  
**Mass Wasting Character:** Displaced soil and flowing rock  
**Hunter/Jacobs Mitigation Design:** Minor Drainage Crossing Repair

View looking at drainage crossing (left) and boulder on pipe (below), August 4, 2010. Photo: Utilities Division, City of Flagstaff

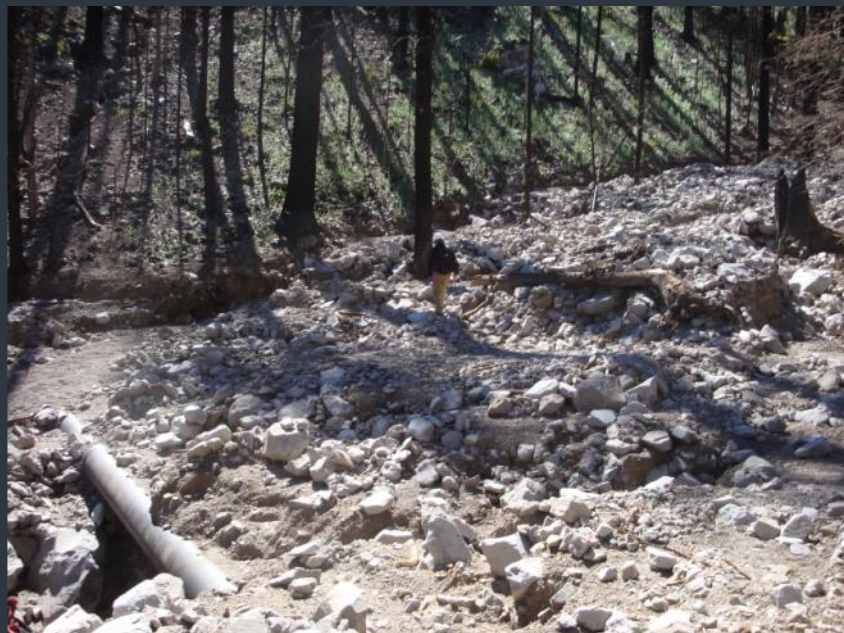
## SITE 24 POST-MONSOON

View looking at drainage crossing on September 9, 2010. Compare with photo on opposite page. Photo: FEMA
